# 2020 CAPITAL REGION PRISM

Aquatic Invasive Species Surveys  
*Early Detection Team Report*

# 2020 Capital Region Aquatic Invasive Species Surveys

November 2020

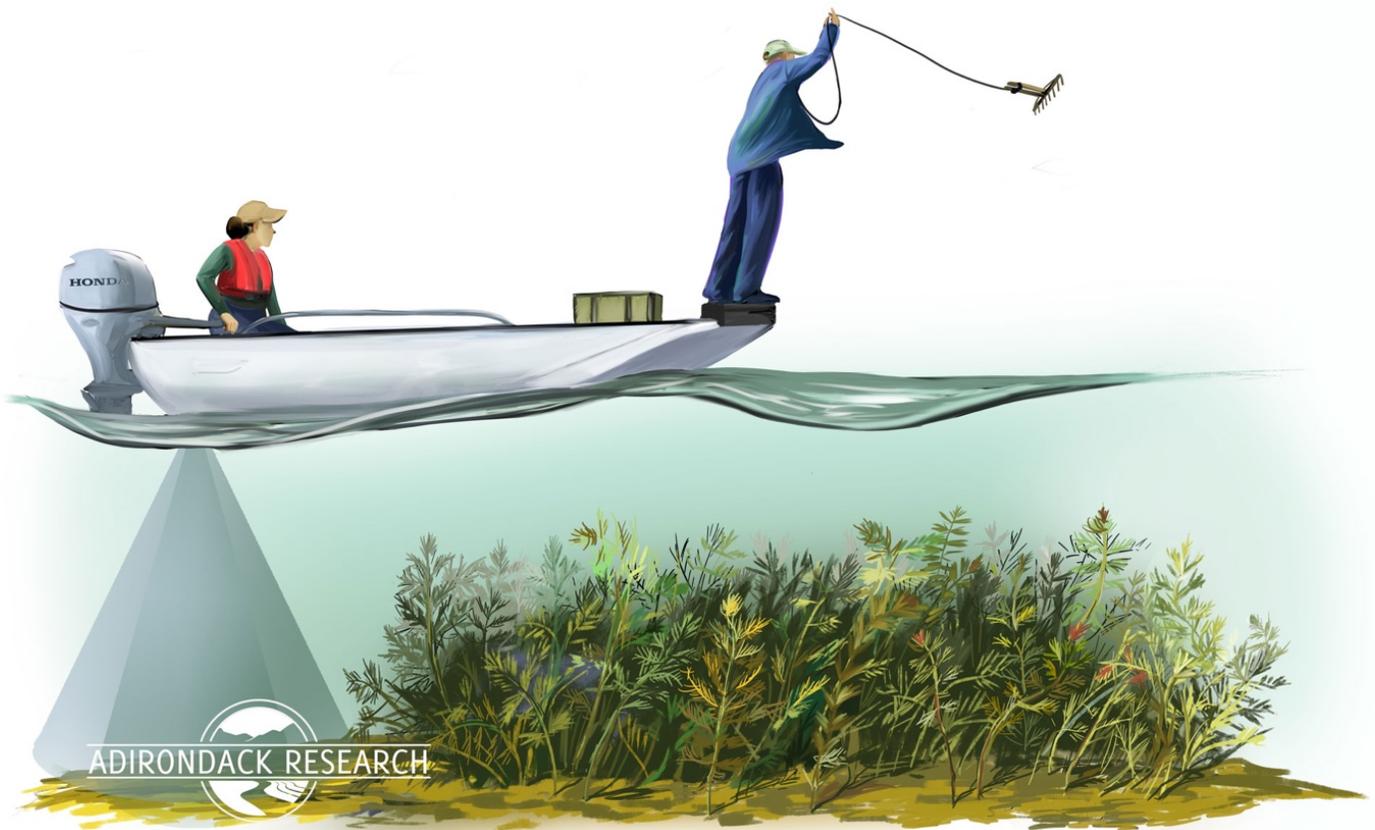
Figure 1: Illustration of the survey techniques utilizing a combination of sonar recording and manual rack toss.

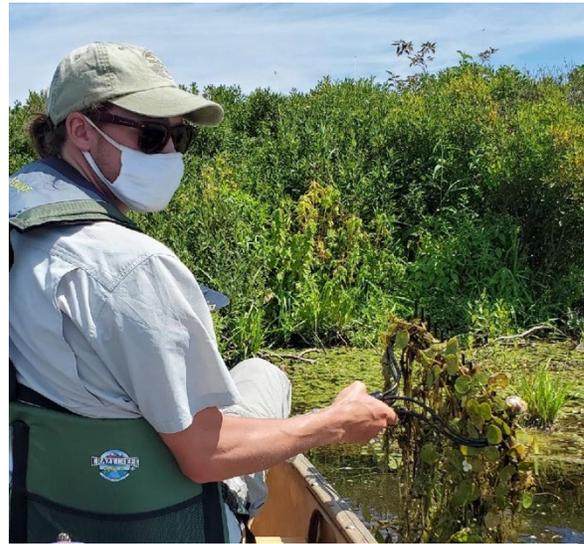
**Photo 2:** Research technician Patrick Bly with a dense rake toss of European frog-bit from Weaver Lake, August 2020.

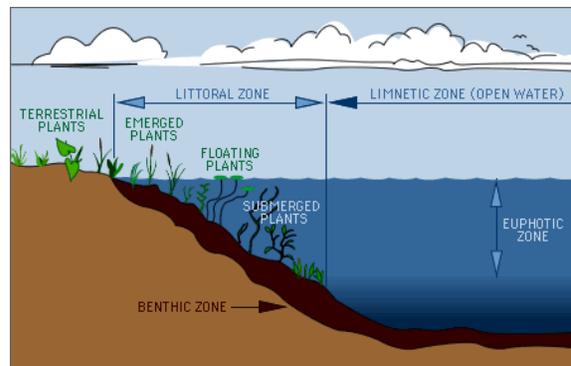
**Figure 2:** Illustration depicting the littoral zone on a waterbody.

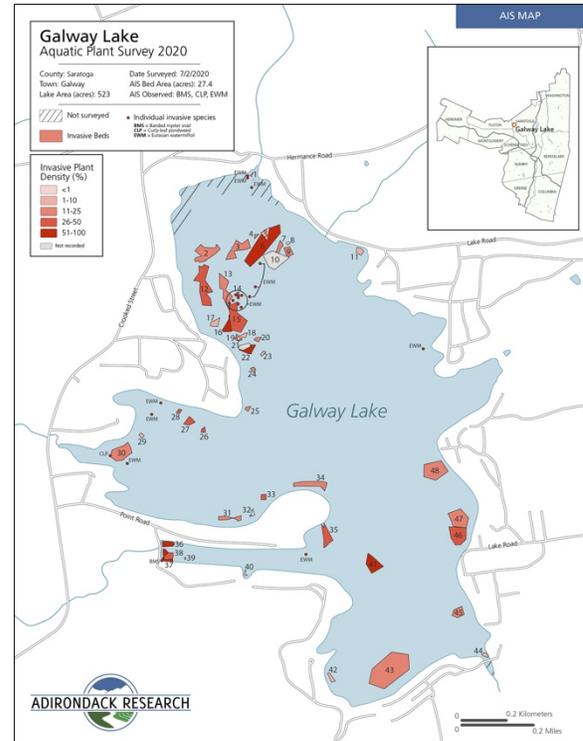
**Figure 4:** Example of AIS polygon delineated on a waterbody in the Capital Region.

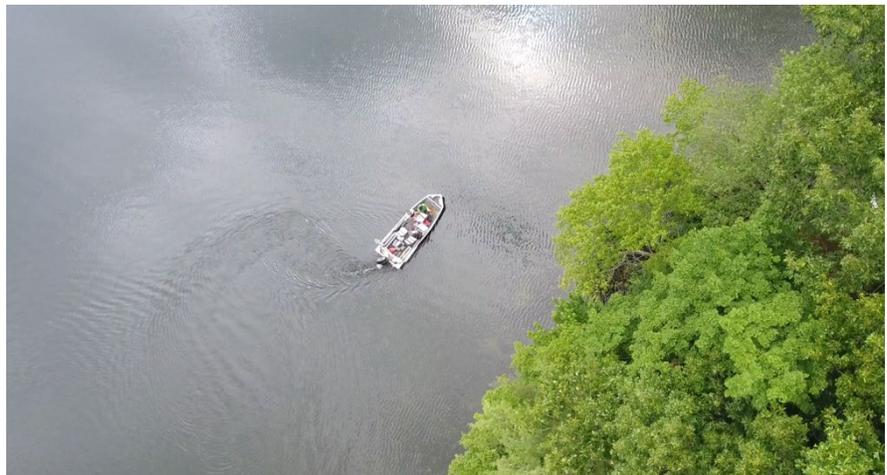
Photo 12: Research vessel performing 'zig-zag' patterns on Lake Sunnyside, June 2020.

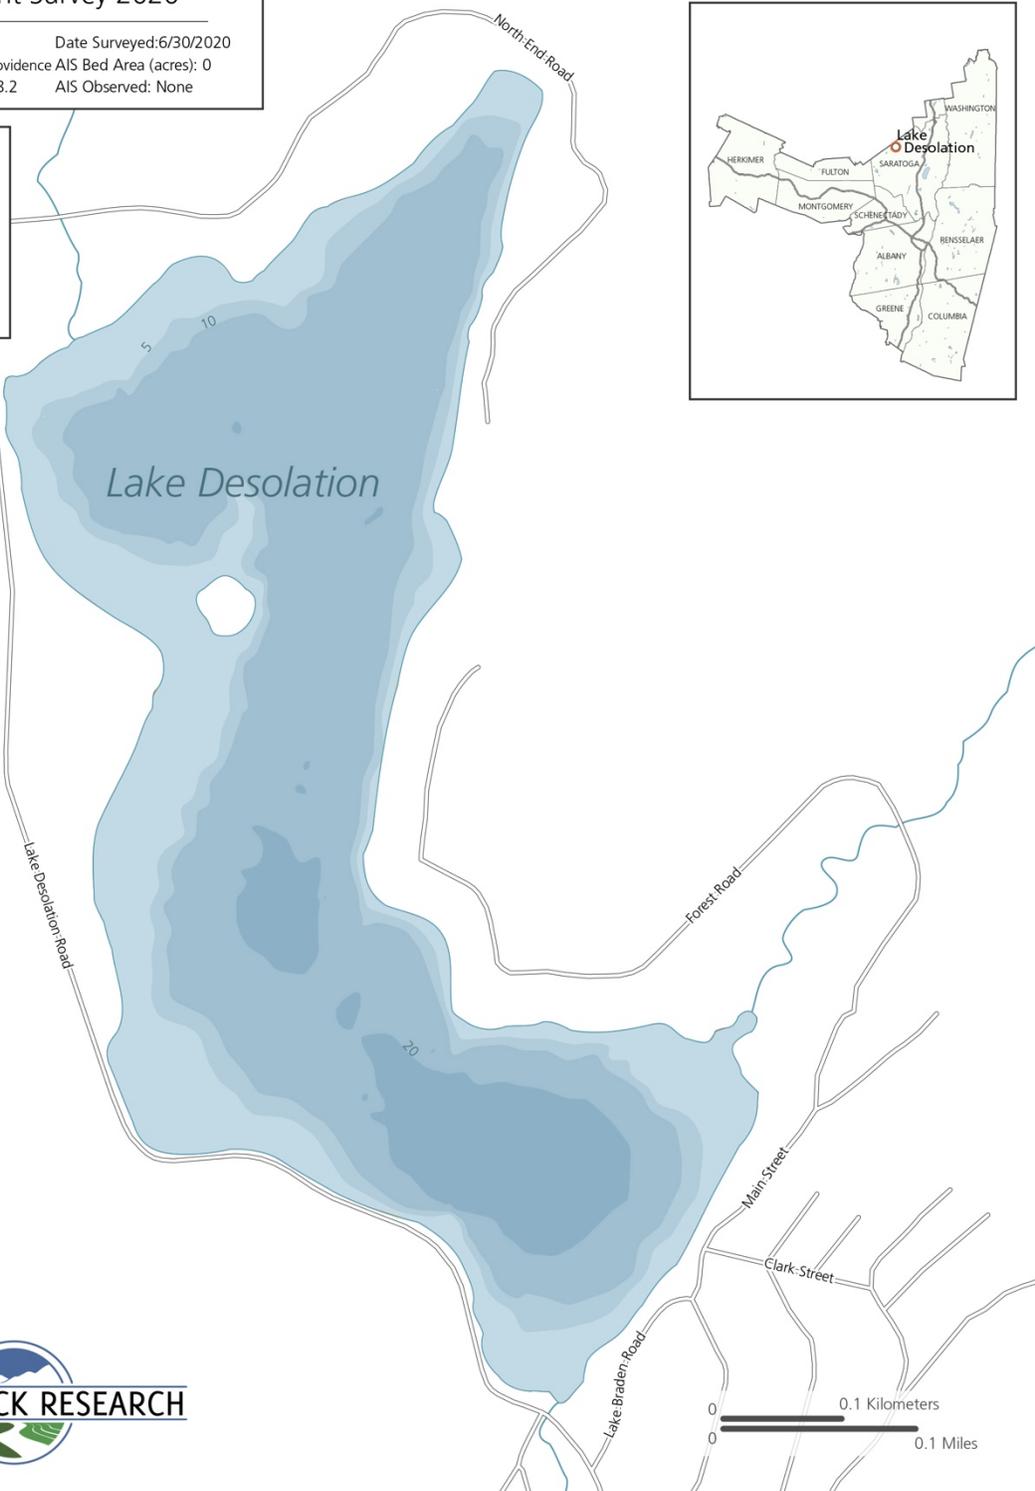
### BATHYMETRY MAP

County: Saratoga      Date Surveyed: 6/30/2020  
Town: Greenfield/Providence      AIS Bed Area (acres): 0  
Lake Area (acres): 68.2      AIS Observed: None

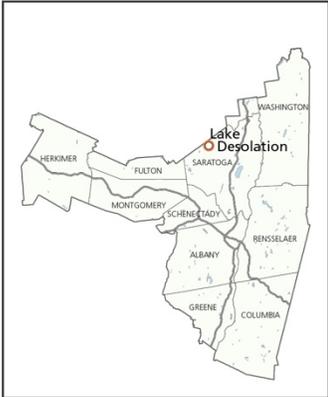
**HARDNESS MAP**

County: Saratoga      Date Surveyed: 6/30/2020  
Town: Greenfield/Providence      AIS Bed Area (acres): 0  
Lake Area (acres): 68.2      AIS Observed: None

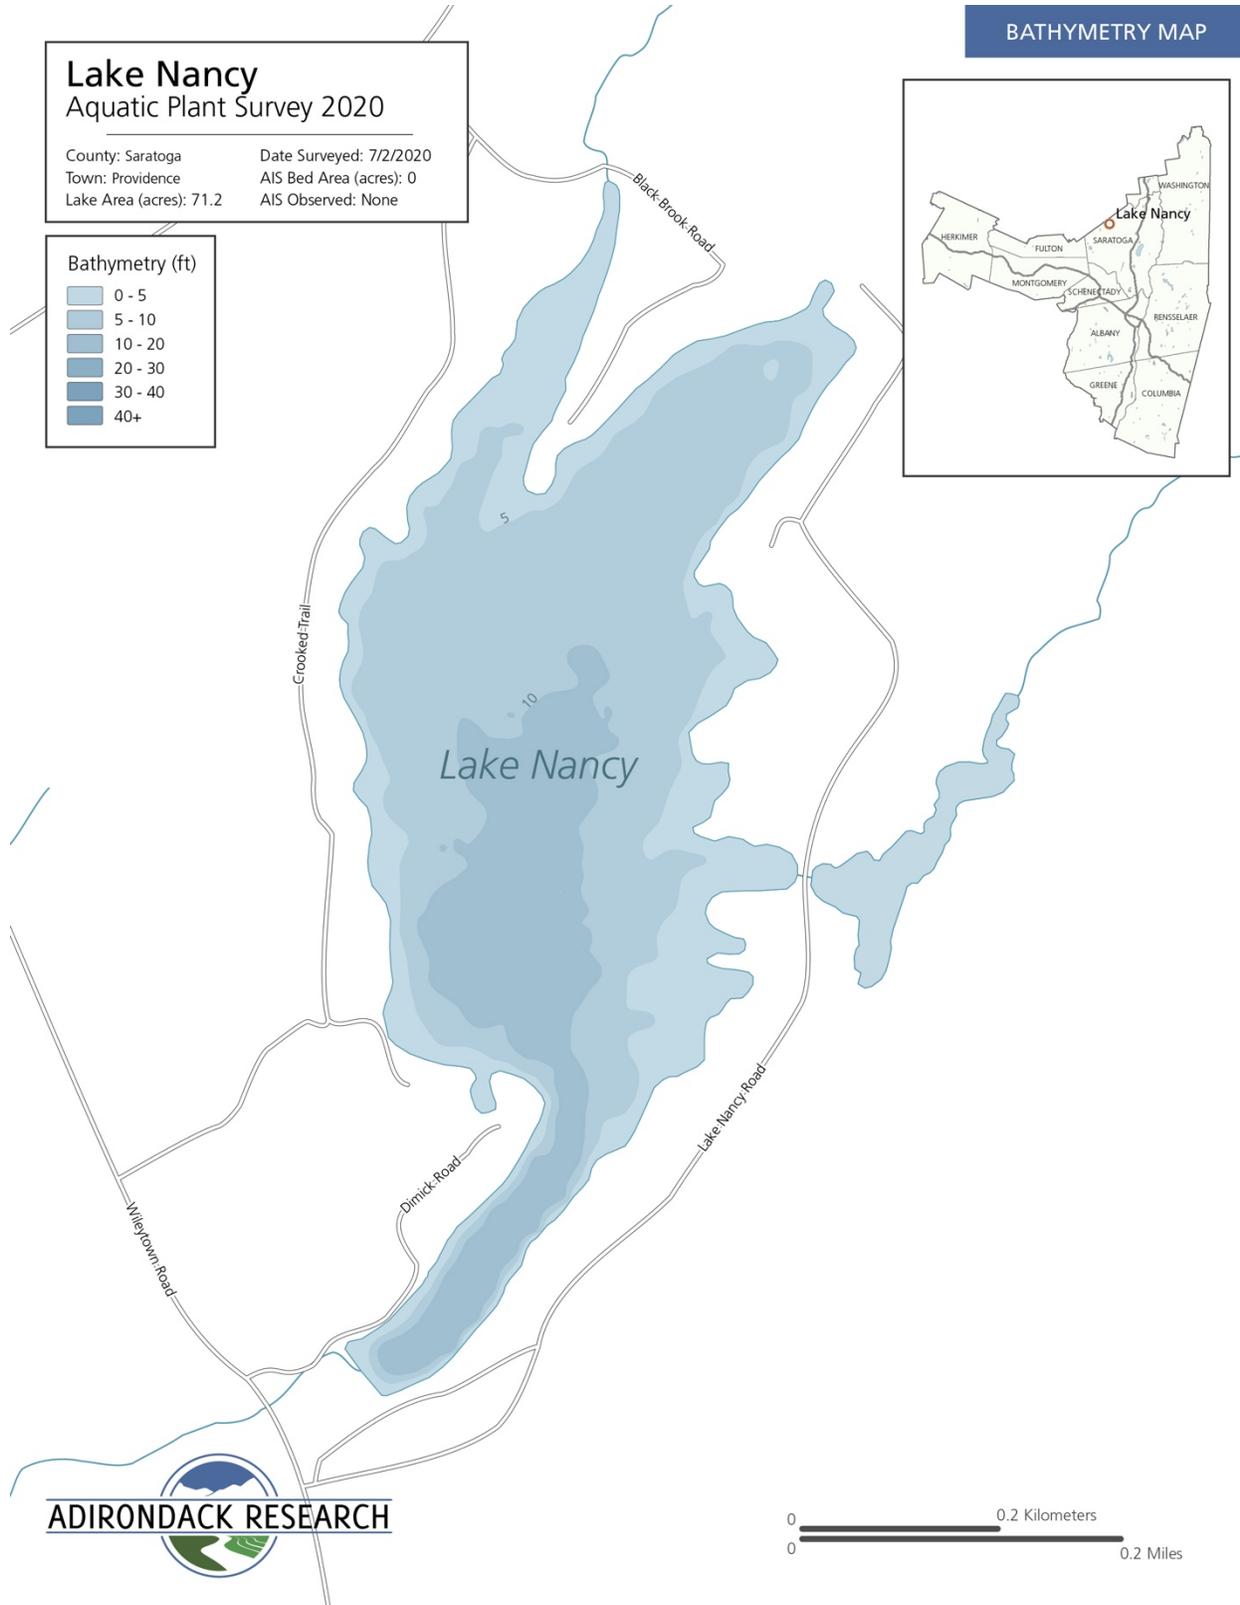
## BATHYMETRY MAP

County: Saratoga      Date Surveyed: 7/2/2020  
Town: Providence      AIS Bed Area (acres): 0  
Lake Area (acres): 71.2      AIS Observed: None

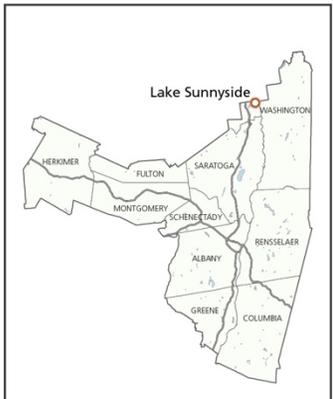
**AIS MAP**

Two aquatic invasive species were found, *Myriophyllum spicatum* (Eurasian watermilfoil) and *Potamogeton crispus* (curly-leaf pondweed).

County: Warren      Date Surveyed: 06/30/2020  
 Town: Queensbury      AIS Bed Area (acres): 0.45  
 Lake Area (acres): 39.4      AIS Observed: CLP, EWM

EWM = Eurasian watermilfoil  
 CLP = Curly-leaf pondweed

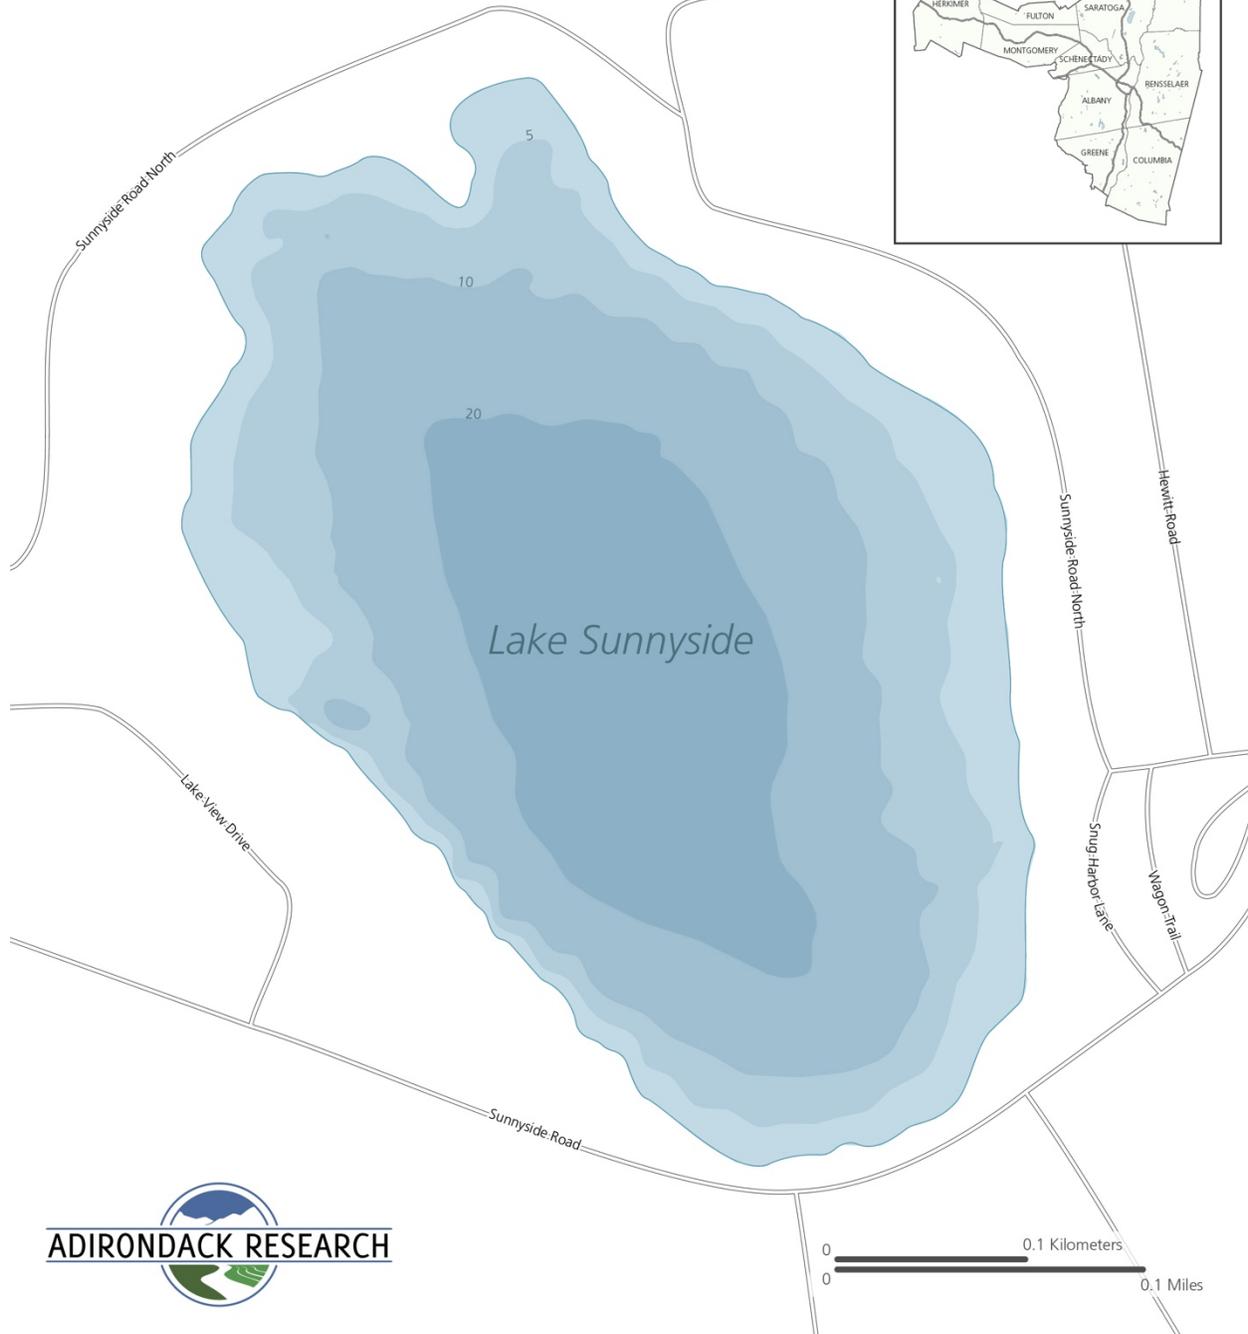
## BATHYMETRY MAP

County: Warren      Date Surveyed: 06/30/2020  
Town: Queensbury      AIS Bed Area (acres): 0.45  
Lake Area (acres): 39.4      AIS Observed: CLP, EWM

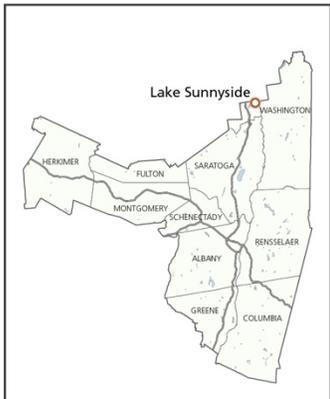
### HARDNESS MAP

County: Warren      Date Surveyed: 06/30/2020  
Town: Queensbury      AIS Bed Area (acres): 0.45  
Lake Area (acres): 39.4      AIS Observed: CLP, EWM

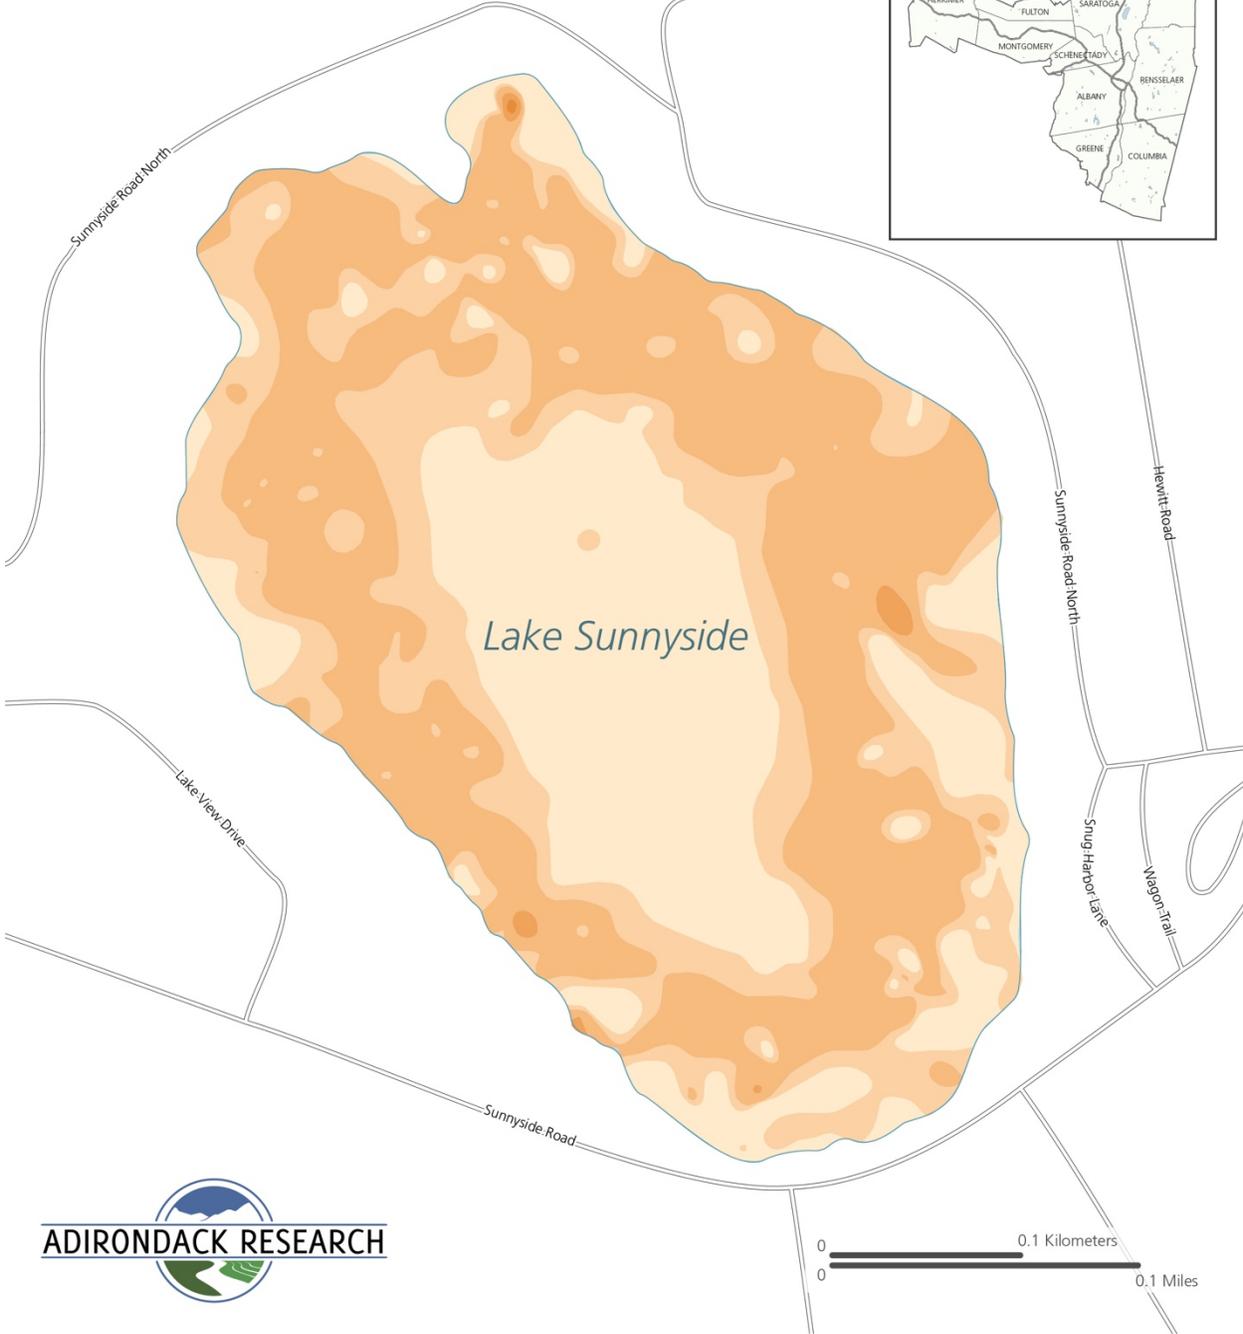
The next and last map is the bottom hardness map. The values of bottom hardness range from 0 to 255 and are an interpretation of sonar made by ReefMaster. The values are linear in hardness and range from the low end of 0, denoting a mucky bottom to 255, denoting a sandy or hard bottom.

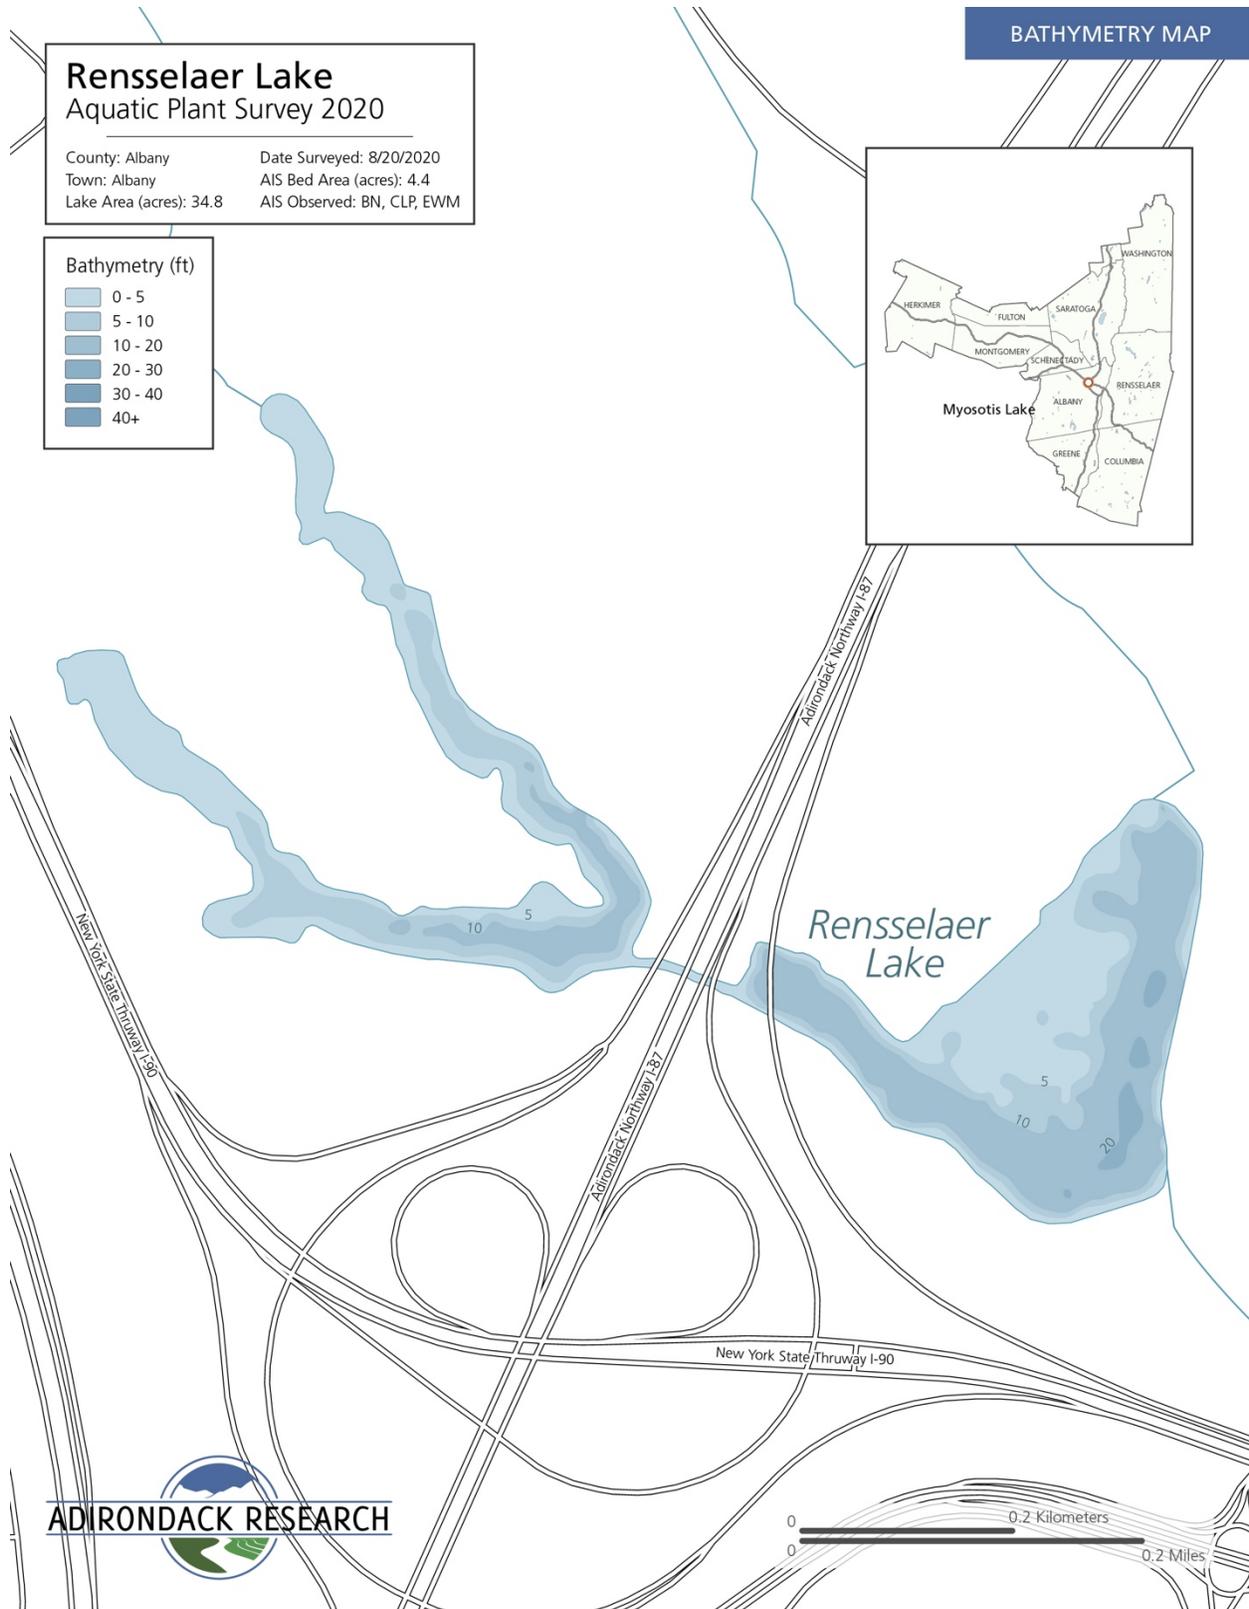
### BATHYMETRY MAP

County: Albany      Date Surveyed: 8/20/2020  
Town: Albany      AIS Bed Area (acres): 4.4  
Lake Area (acres): 34.8      AIS Observed: BN, CLP, EWM

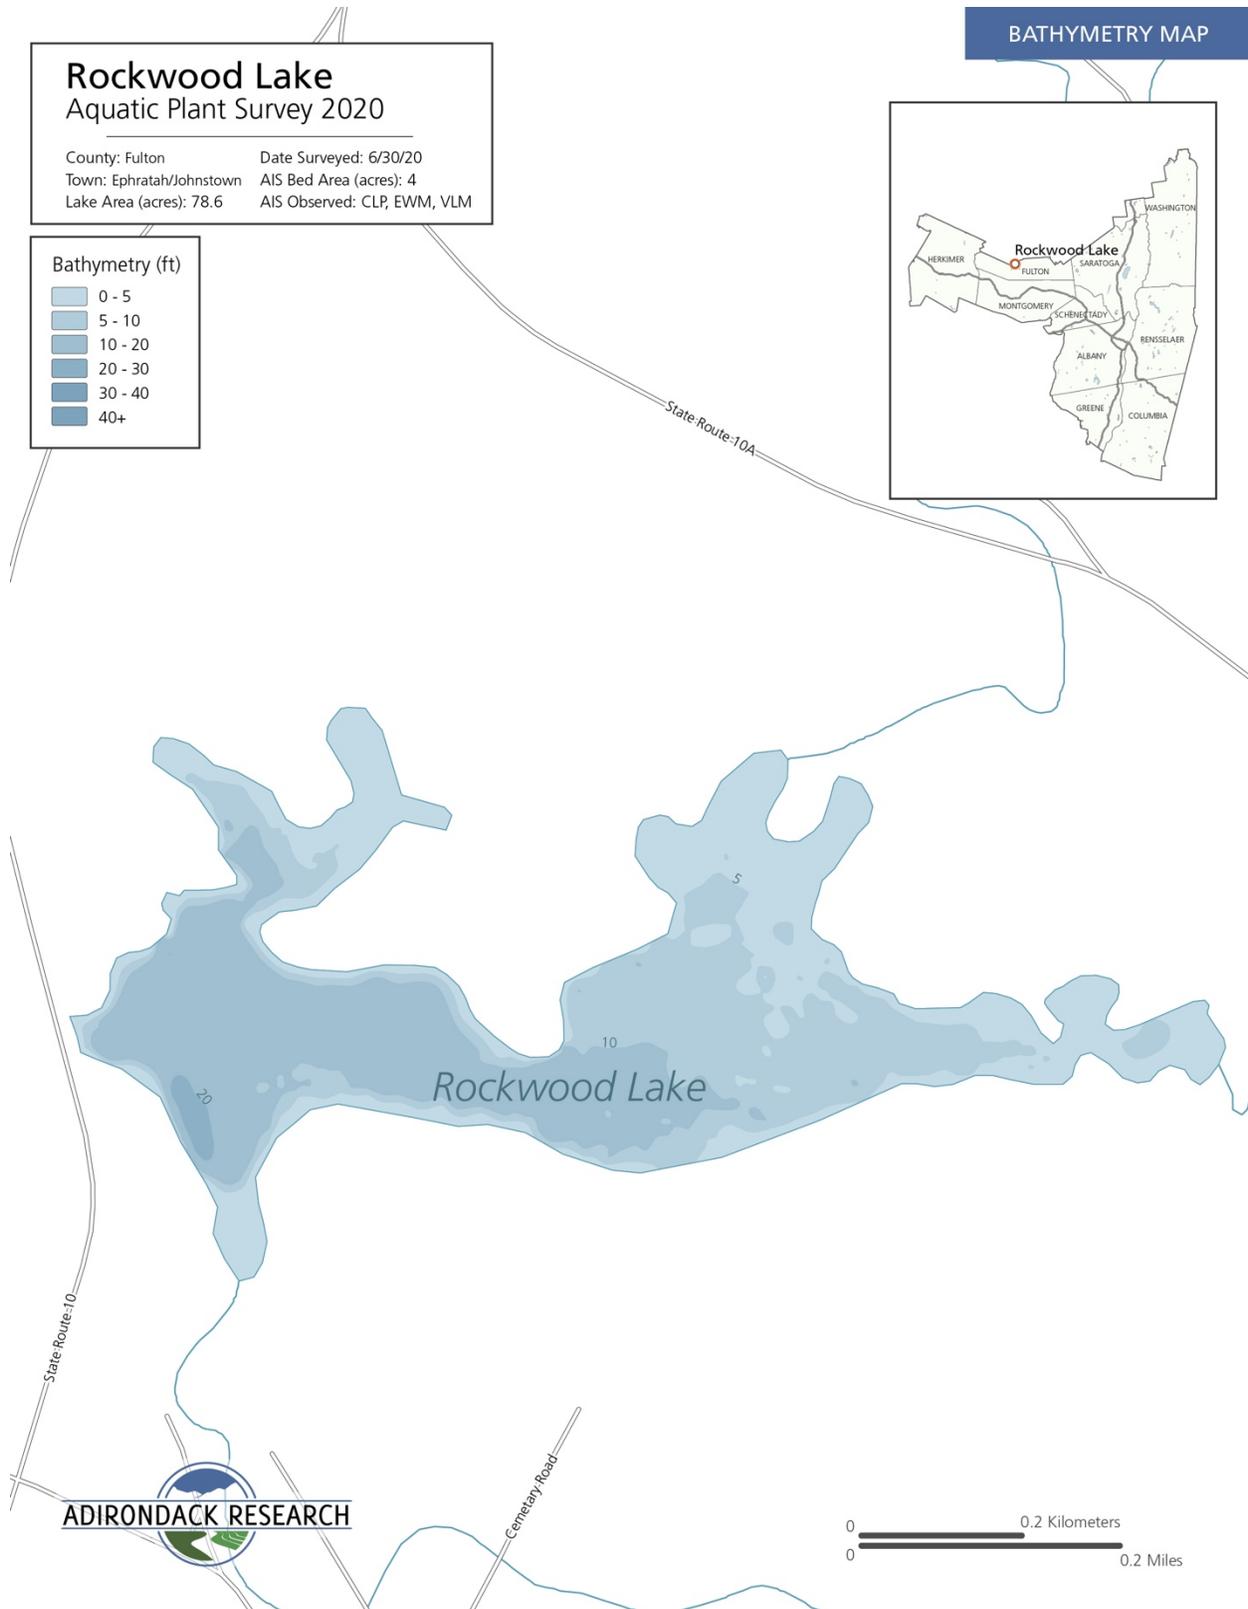
### BATHYMETRY MAP

County: Fulton Date Surveyed: 6/30/20  
Town: Ephratah/Johnstown AIS Bed Area (acres): 4  
Lake Area (acres): 78.6 AIS Observed: CLP, EWM, VLM

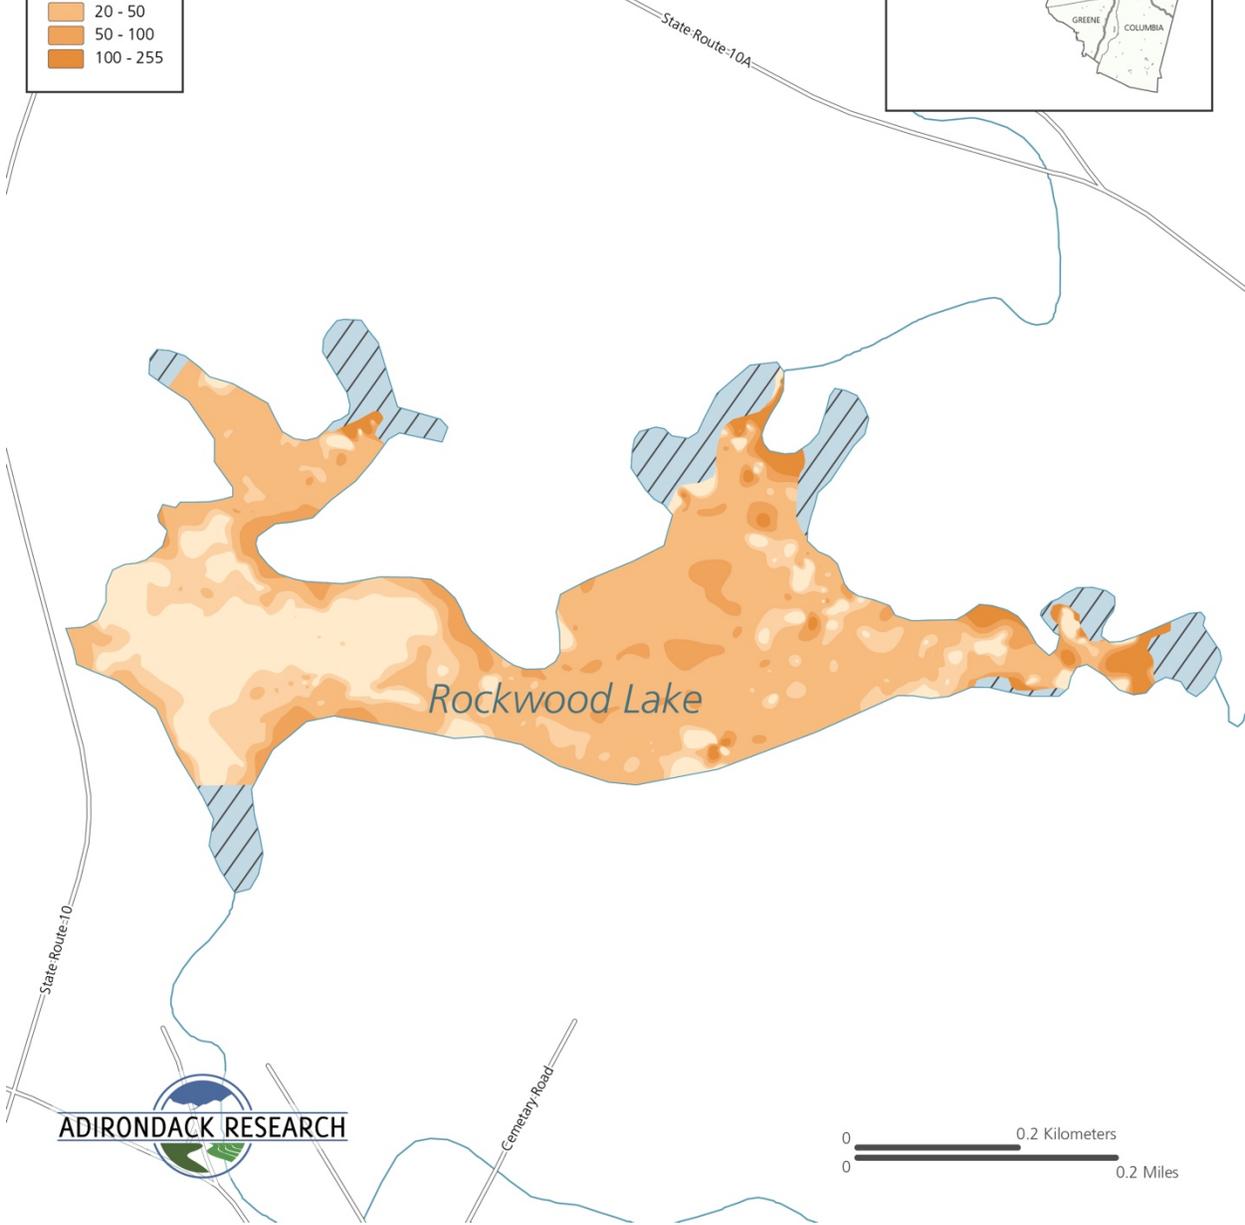
**HARDNESS MAP**

County: Fulton      Date Surveyed: 6/30/20  
 Town: Ephratah/Johnstown      AIS Bed Area (acres): 4  
 Lake Area (acres): 78.6      AIS Observed: CLP, EWM, VLM

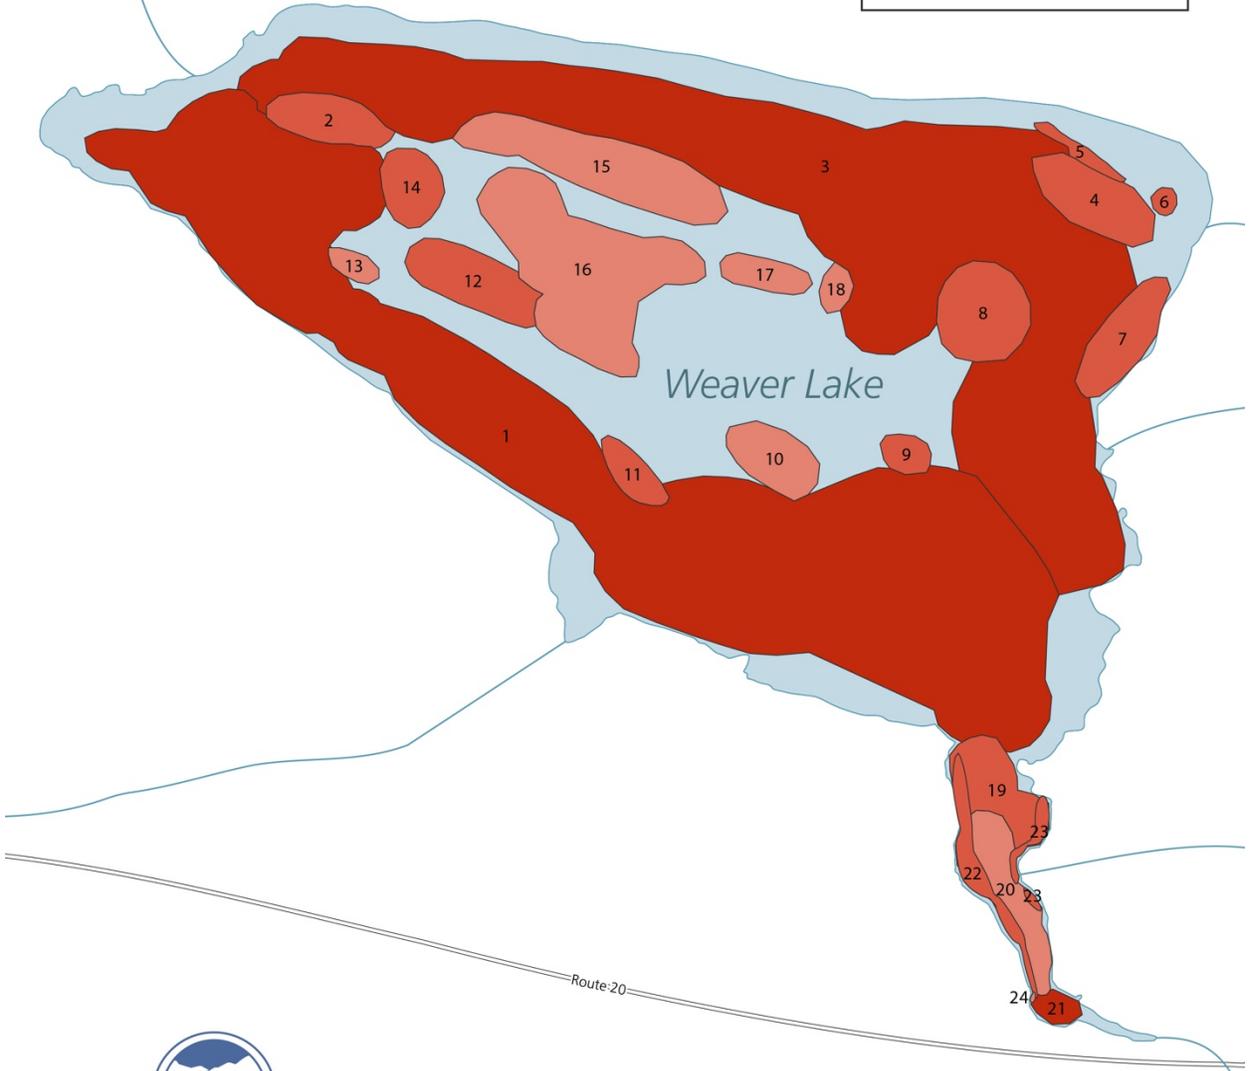
Invasive Beds

Several aquatic invasive species were found, *Myriophyllum spicatum* (Eurasian watermilfoil), *Potamogeton crispus* (curly-leaf pondweed), and *Hydrocharis morsus-ranea* (European frogbit)) were detected throughout the whole waterbody.

County: Herkimer      Date Surveyed: 8/11/2020  
 Town: Warren      AIS Bed Area (acres): 81  
 Lake Area (acres): 113.2      AIS Observed: CLP, EFB, EWM

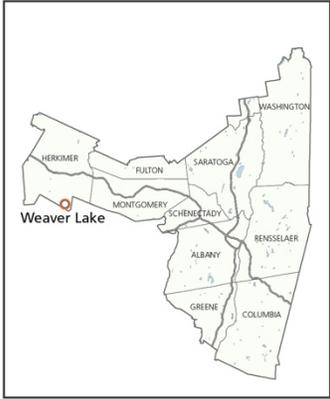
**BATHYMETRY MAP**

County: Herkimer      Date Surveyed: 8/11/2020  
Town: Warren      AIS Bed Area (acres): 81  
Lake Area (acres): 113.2      AIS Observed: CLP, EFB, EWM

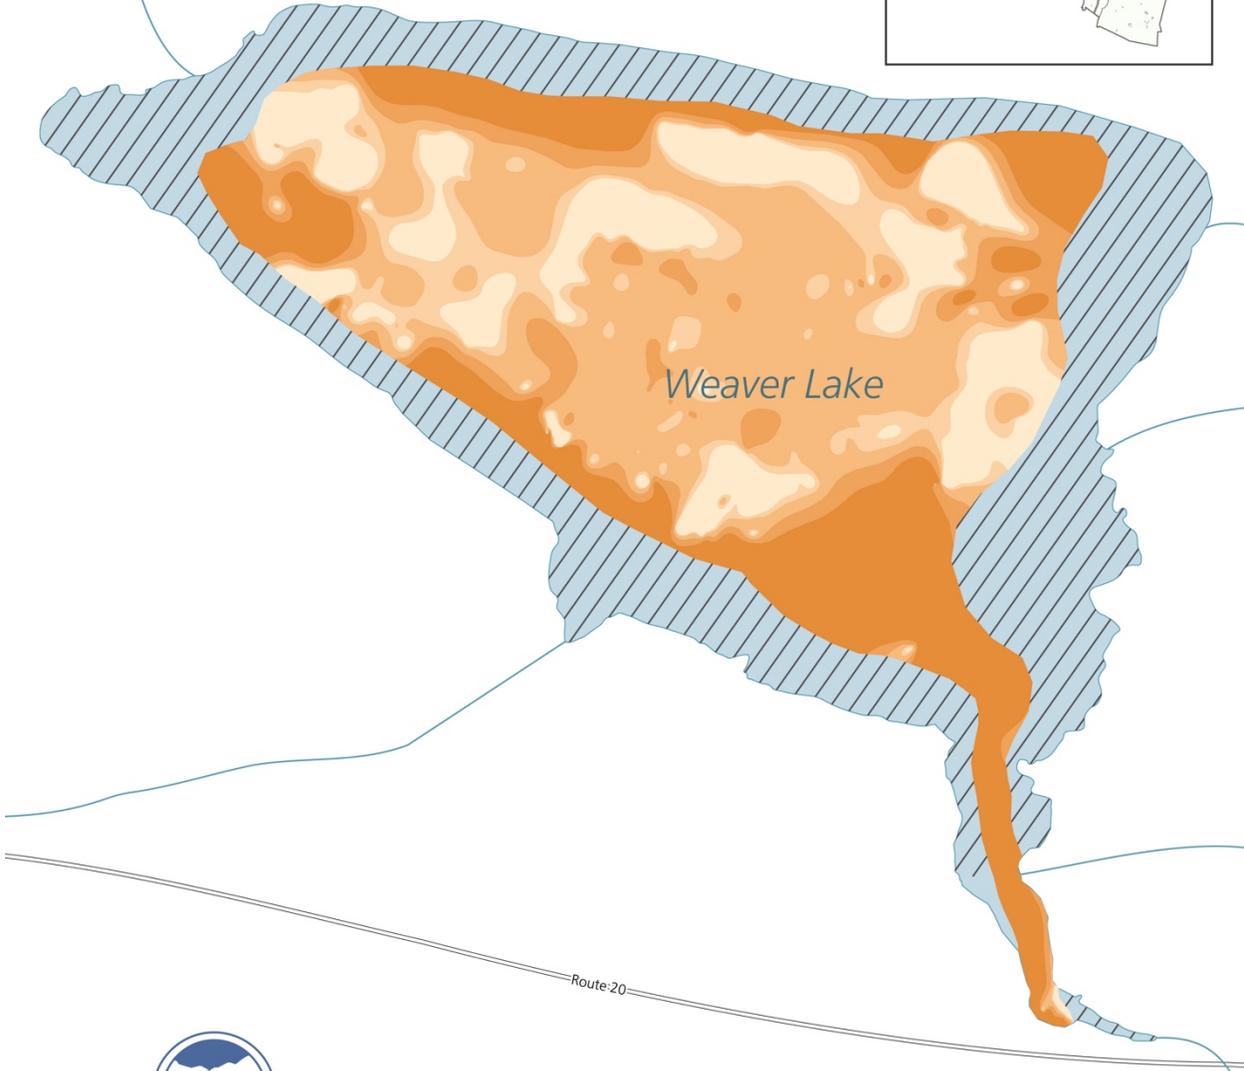
**HARDNESS MAP**

County: Herkimer      Date Surveyed: 8/11/2020  
Town: Warren      AIS Bed Area (acres): 81  
Lake Area (acres): 113.2      AIS Observed: CLP, EFB, EWM
