# Capital Region Aquatic Plant Surveys

*2023 Report*

# 2023 Capital Region Aquatic Invasive Species Surveys

Ezra Schwartzberg, Ph.D., Justin Wolford, Tucker Wells, Tucker Jakobe, and Julia Luna  
Adirondack Research  
November 2023

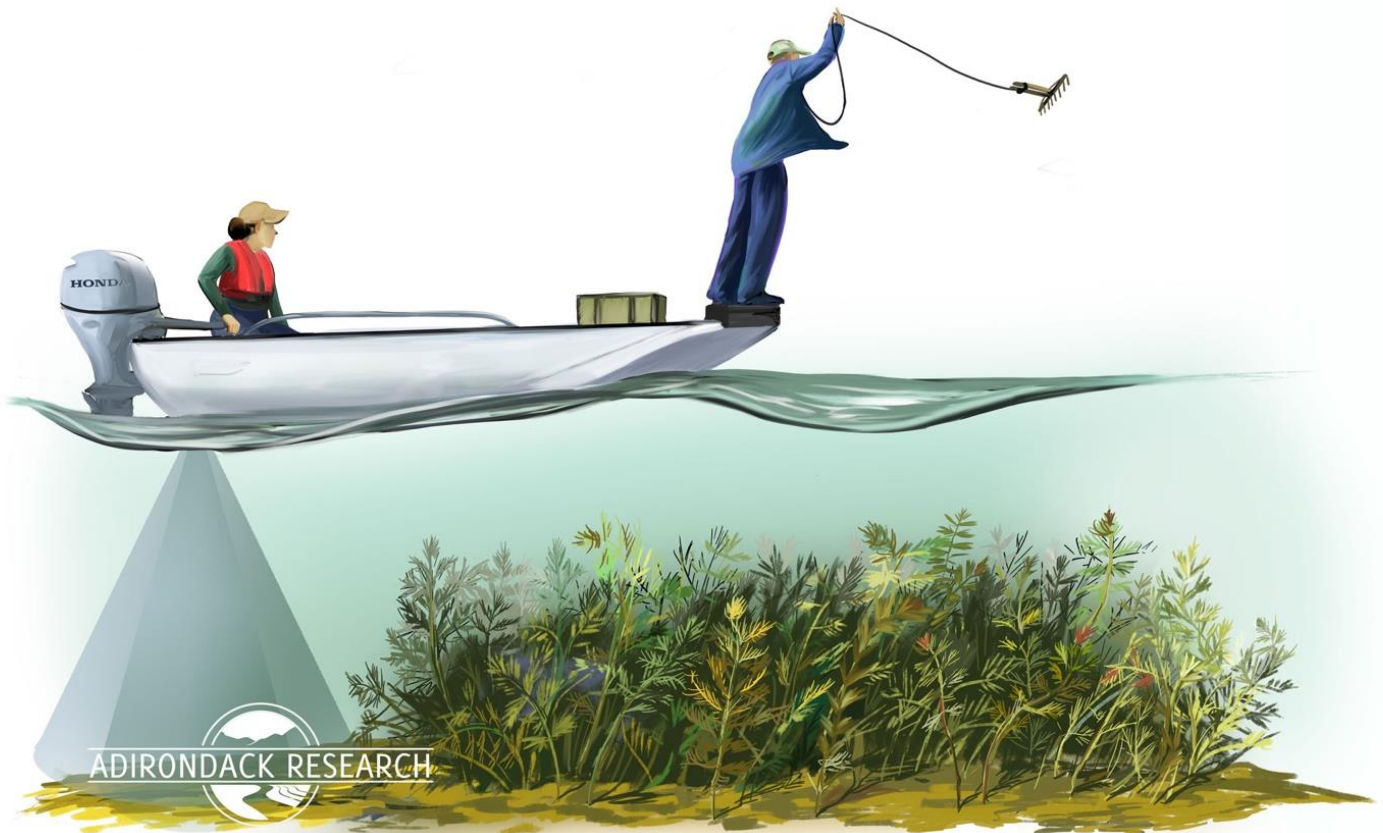
Figure 1: Illustration of the survey techniques utilizing a combination of sonar recording and manual rack toss.

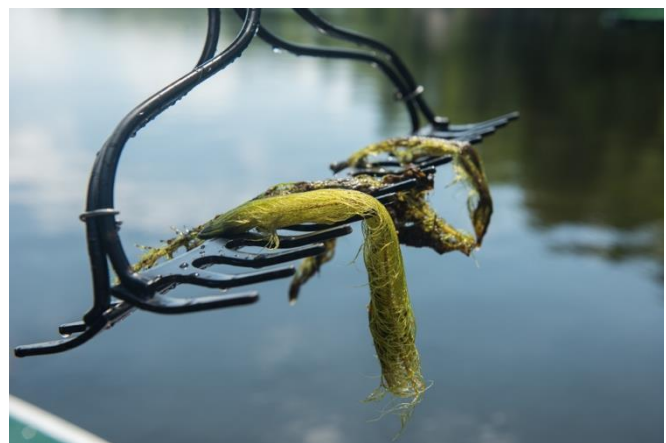
**Photo 9:** A rake toss sample with Eurasian watermilfoil.

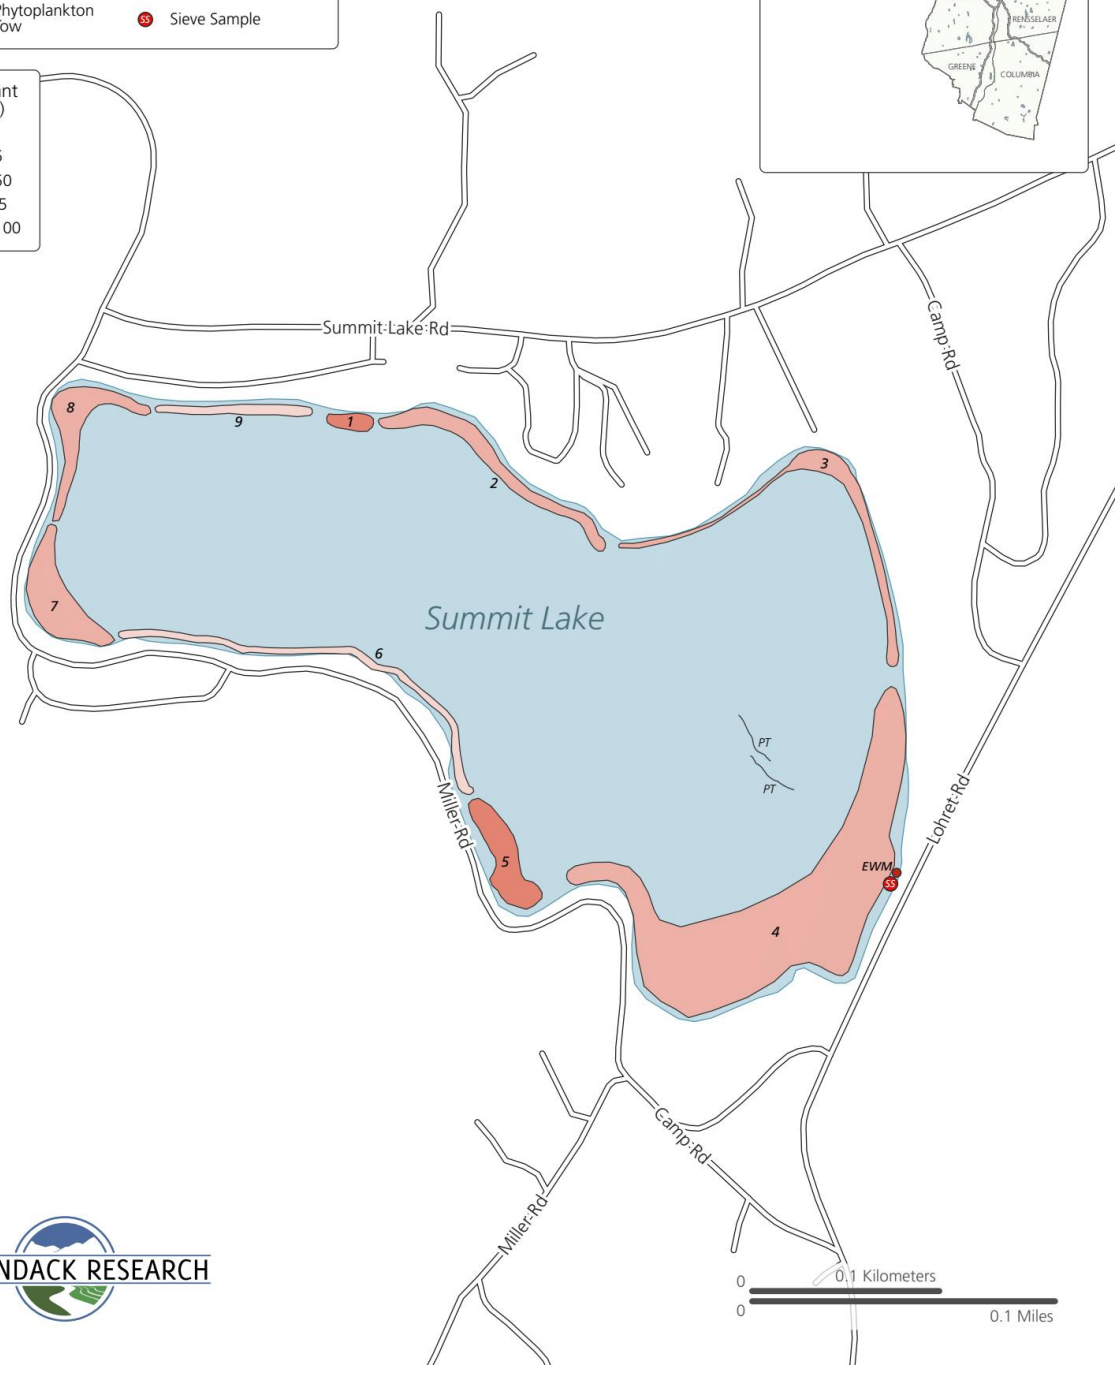
## Summit Lake

County: Washington      Date Surveyed: 26/07/2023  
 Town: Argyle              AIS Bed Area (acres): 14.3  
 Lake Area (acres): 82.3      AIS Observed: EWM
