Capital Region PRISM AIS Water Chestnut Treatment/Response Report

Cheviot Park, Germantown NY

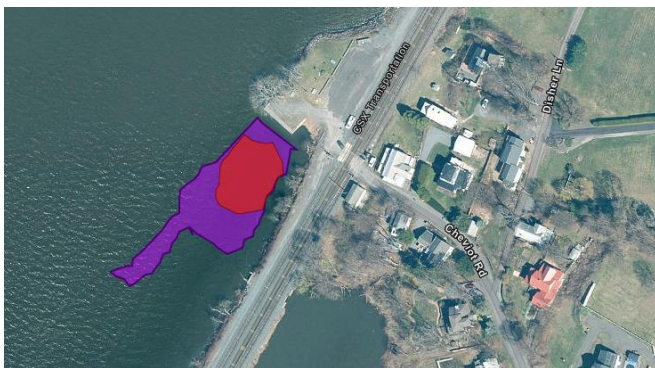
Purple polygon indicates the greater survey area (0.63acres), while the red polygon depicts the treatment area(0.26acres).
Treatment mapped using iMap Mobile Advanced (IMMA).

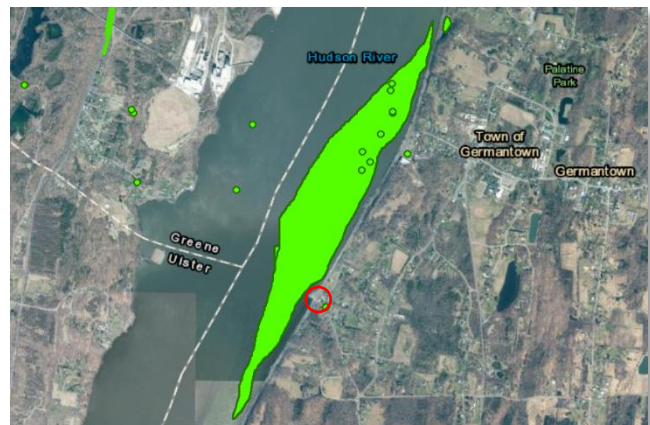
Green polygon created in 2018 shows the infested area. A large monoculture is present, equating to **185 acres**.
Circled area shows where treatment occurred.

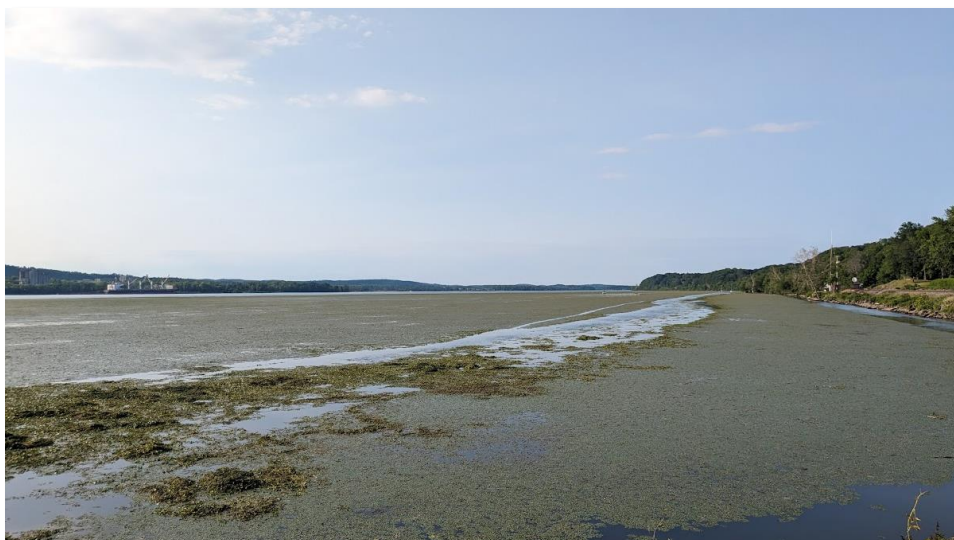
Photo by Martin Overington, 2023. Water chestnut monoculture leading to Icehouse Landing location
