Capital Region PRISM AIS Lake Survey Report

Date: August $18^{\mbox{\tiny th}}$ and $26^{\mbox{\tiny th}}$ 2020

Site Name: Tomhannock Reservoir

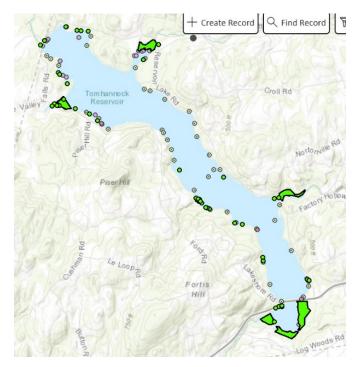
Map: Searched/Presence Areas: Tomhannock Reservoir (Entire Littoral Zone)

Water Chestnut (*Trapa natans*) Monoculture Tomhannock Reservoir 2020

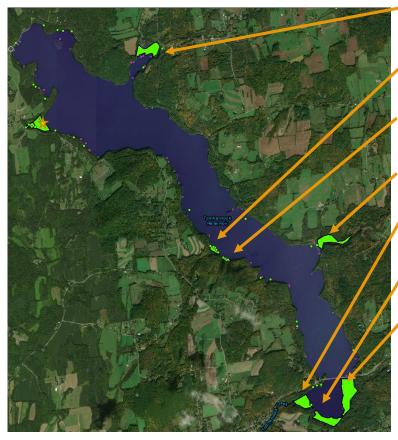
The Presence polygons in green where dense monocultures of Water Chestnut (Trapa natans) are confirmed.

Polygon data was delineated using ARC GIS Collector in the field.

- **Polygon 1** *iMap Invasives Presence Record ID: #1064700 Location: 42.86744 °-73.55809 ° Area: 52264.97 m² (12.91 Acres)*
- Polygon 2 iMap Invasives Presence Record ID #1064699 Location: 42.83815 ° -73.54509 ° Area: 8689.08 m² (2.14 Acres)

Polygon 3 *iMap Invasives Presence Record ID #1064701 Location: 42.8368° -73.54286° Area: 847.7 m² (0.21 Acre)*

Polygon 4 iMap Invasive Presence Record ID #1064698 Location: 42.8395° -73.52187 ° Area: 48819.73 m² (12.1 Acres)

Polygon 5 *iMap* Invasives Presence Record ID #1064695 *Location:* 42.81579 °-73.52717 ° *Area:* 37388.06 m² (9.3 Acres)

Polygon 6 *iMap Invasives Presence Record ID #1064696 Location: 42.81326 °-73.52247 ° Area: 47272.29 m² (11.7 Acres)*

Polygon 7 iMap Invasives Presence Record ID #1064697 Location: 42.81709 °-73.51834 ° Area: 95075.53 m² (23.5 Acres)

*Upper left polygon in the North West is not a presence polygon from this survey and does not represent a monoculture, however water chestnut is found in this area in trace and sparse populations. *iMap Invasives Presence* Record *ID* #334979 <u>David Newman - 4221</u> 6.7.2012

Chemical treatment is not an option for the public water supply.

Bio-Based mapping should possibly be considered to determine the possible extent in which soft sediments occur in the reservoir within the littoral zone. These areas can represent possible environments for future expansion of the plant into new un-established habitat.

Water chestnut overwinters entirely by seeds that may remain viable in the sediment for up to 12 years, repeated annual control is critical to deplete the seed bank. Treatment generally is needed for five to twelve years.
Shallow water aquatic weed harvesters maybe needed for control / eradication in sections of the littoral zone in conjunction with larger harvesters. Some hand pulling maybe required.
