Capital Region Partnership for Regional Invasive Species Management Aquatic Detection & Monitoring Report

Section 1: Survey Summary

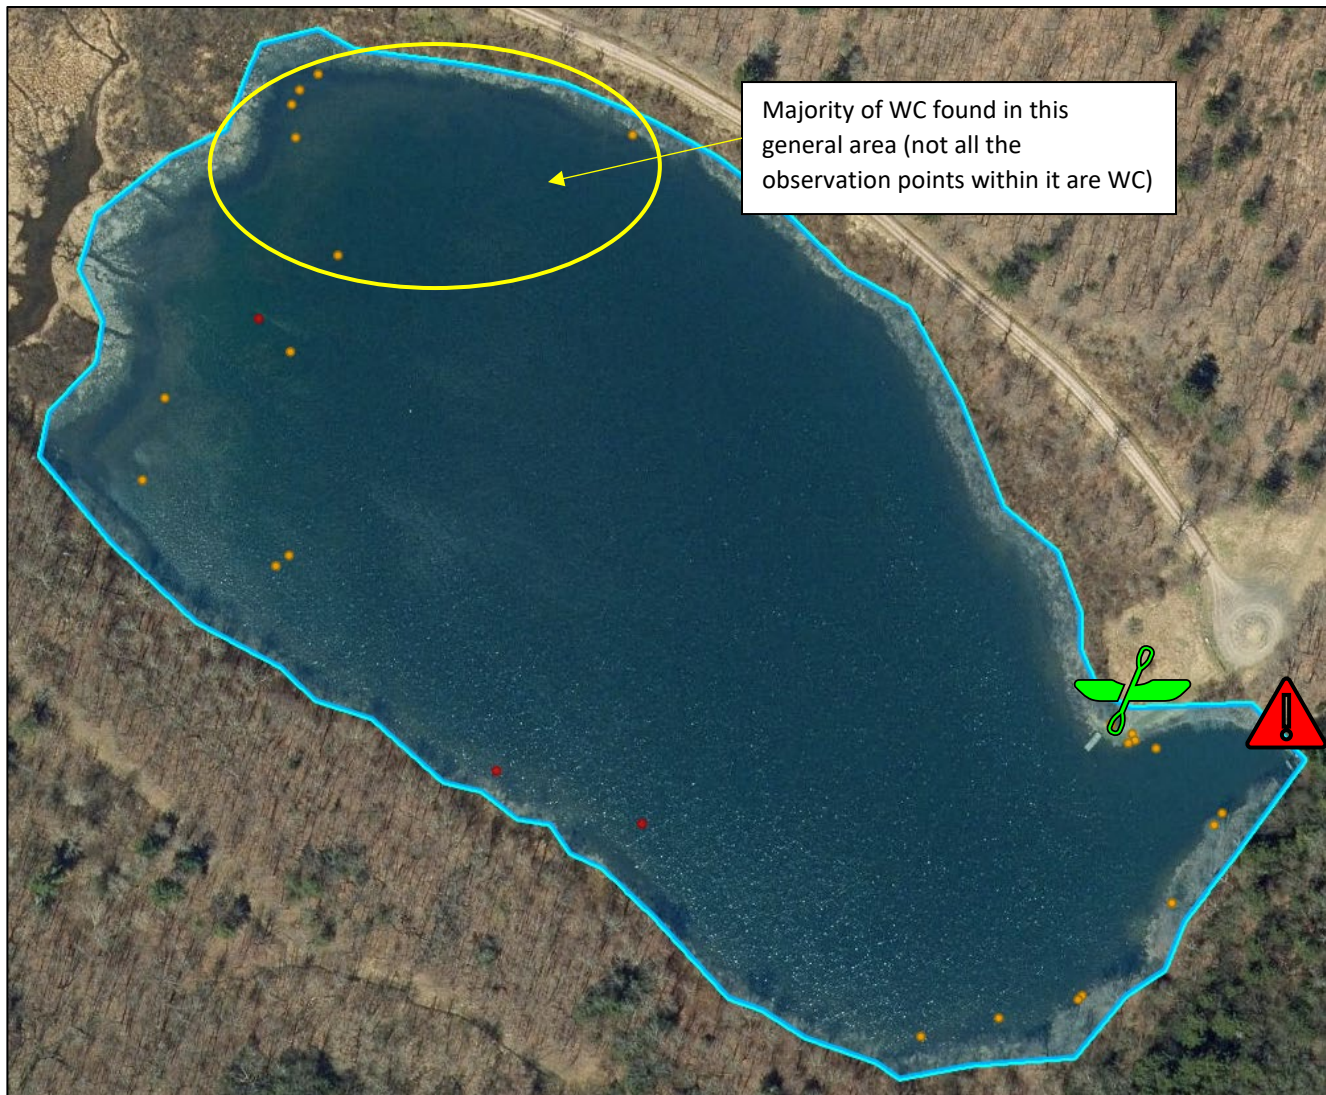
Figure 2. Fawn Lake survey area. Blue outline = searched area; yellow-orange circles = species detected outside rake toss; red circles = rake toss; location of Water Chestnut denoted with bright yellow oval; boat launch denoted with bright green kayak symbol; dam/spillway denoted with red hazard symbol.

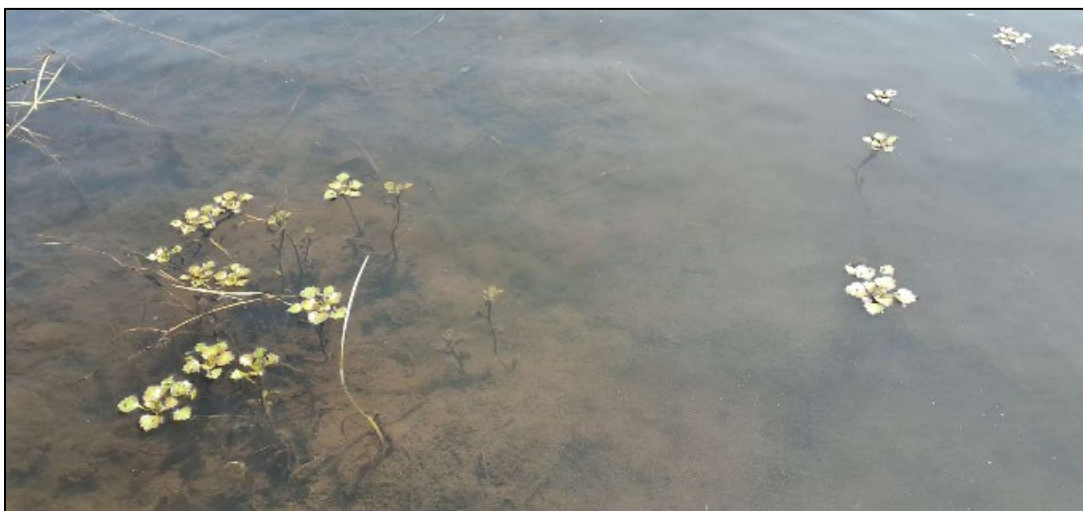
The only AIS detected in Fawn Lake was small amounts of Water Chestnut, mostly in the northwestern portion of the lake—this was expected, given the past observations and removals of water chestnut. All Water Chestnut found was removed on sight, totaling 15-20 small/immature rosettes. Post-treatment monitoring was planned for later in the season to check for any lingering plants that had not yet emerged at the time of this survey.

Figure 7. Water Chestnut.

Small populations of water chestnut (approx. 15-20 plants) were removed, including attached nutlets. The water chestnut plants are still very small/young at this stage in the season and may not have all emerged yet. Regular surveying of this location is recommended to control the small water chestnut population as it would be feasible to eradicate.

Fawn Lake will be surveyed annually or biannually for Water Chestnut and other potential AIS. An Invasive Species Management Plan is not needed at this time.
