Capital Region Partnership for Regional Invasive Species Management Aquatic Response Report

The Cove is an approximately 66-acre tributary of the Upper Hudson River in Schuylerville, New York. It is largely natural area with a handful of residences, with The Alley Bar and Grill at the northern tip. Water Chestnut afflicts the entirety of The Cove, with sparser distribution on the northern end and increasing density as you get closer to the mouth, with up to 100% surface coverage in some areas. The goal of this project was to clear an access path through the monoculture.

Section 1: Response Project Summary

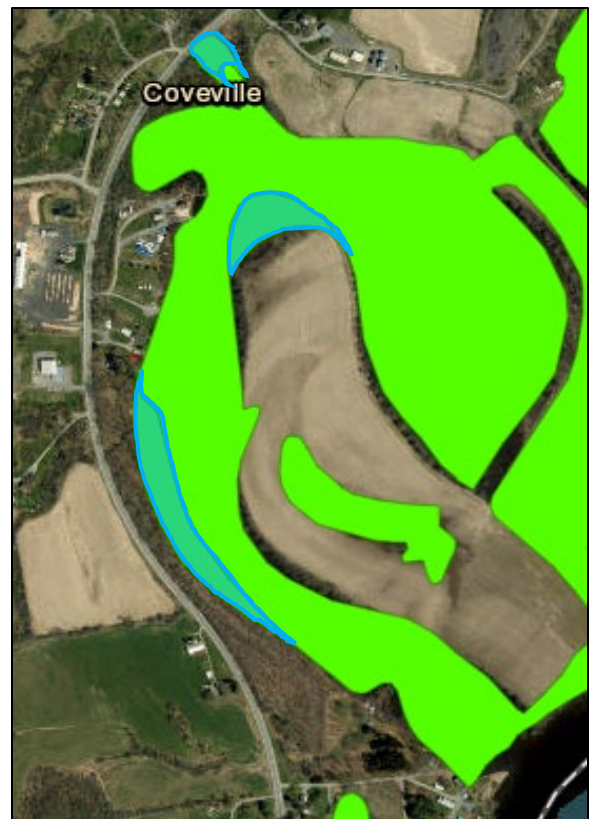
Additionally, there are Class 1 & 2 Freshwater Wetlands present—identified via the [NYSDEC Environmental Resource Mapper](#) (Fig.1)—that are at risk for ecological harm caused by the infestation. While the taller emergent species (i.e. cattail, pickerelweed, etc.) of these wetlands are in less direct competition with Water Chestnut, Water Chestnut causes a reduction in important submersed plants, associated microorganisms, and dissolved oxygen, decreasing the overall quality of the wetlands as a whole (U.S. Fish & Wildlife Service).

Figure 1. Previously Mapped Freshwater Wetlands. Bright green shapes = Class 2 Wetlands; blue = Class 1 wetlands.

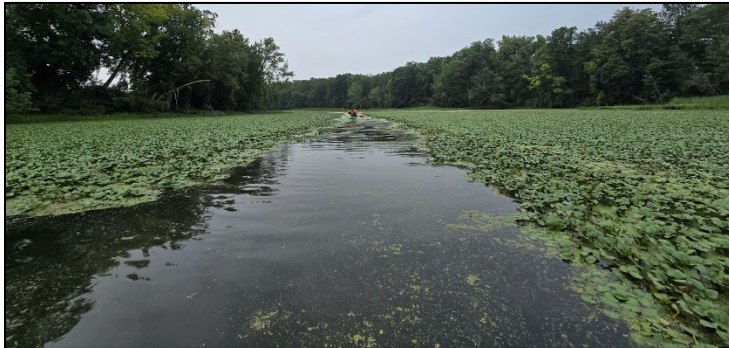
Figure 3. Northern end of 2025 treatment polygon. Water Chestnut is shown covering a majority of the water's surface with only a narrow path down the middle.

At this stage of infestation, it is the opinion of the Capital Region PRISM that hand-pulling alone is no longer an effective approach in the long-term management of the greater Water Chestnut monoculture of The Cove. Despite a large group of participants, several hours of work, streamlining of the hauling process via pontoon, and removal of roughly 1,300 pounds of Water Chestnut biomass (two thirds of a US ton)—there is hardly a detectable change in the population, and The Cove is still nearly impossible to access from the main Hudson River. Hand-pulling may still be appropriate for smaller-scale goals, such as keeping the immediate waterfront clear at The Alley Bar and Grill, or in some extenuating circumstances such as the hurricane damage in 2024.

The deployment of a mechanical harvester could be a viable management strategy for The Cove. Mechanical harvesters are motorized watercraft that remove aquatic weeds by large-scale pulling and/or cutting. There are a variety of harvester types, sizes, and operation methods. Most harvesters work by cutting vegetation below the water's surface or hydro-raking (i.e. dredging); some work by pinching and pulling the plant out of the sediment from the top. Each type has its pros and cons—for example, some AIS propagate by fragmentation (such as Eurasian Watermilfoil) and can grow from the abundance of cut fragments left in the water from cutting-type harvesters, though it can also be a quick and effective method for other species and is commonly used for Water Chestnut; hydro-raking heavily disturbs the sediment but can remove a large amounts of biomass and can help deplete the existing seed bank; pinch-pulling effectively removes plants from the root and can operate in extremely shallow water, but can cause disturbance to the sediment similar to hand-pulling but on a larger scale. Each method also has its own implications for permitting, whether it involves disturbance of regulated freshwater wetlands, navigable waters, etc.

Local eradication of the entire 40+ acre infestation may not be realistic without intense response measures such as repeated, large-scale hydro-raking and/or herbicide application. At a minimum, a more realistically attainable strategy would be to clear/widen/maintain an access path through the middle of the infestation via annual or semi-annual deployment of a mechanical harvester. Once cleared, such a path would be more easily maintained by supplemental hand-pulling of any regrowth during the season.

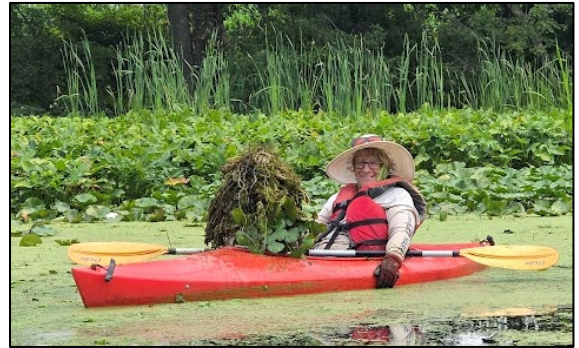
Figure 4. Biomass pile! Co-owner MaryAnn Still pictured with a heaping pile of Water Chestnut in her lap.

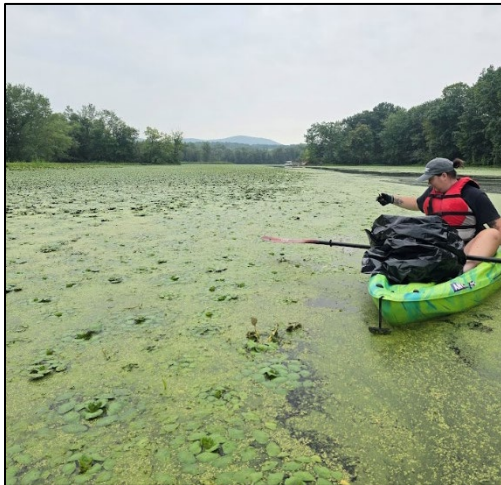
Figure 5. Pulling in action. CR-PRISM Steward Natalie Myers shown pulling Water Chestnut.

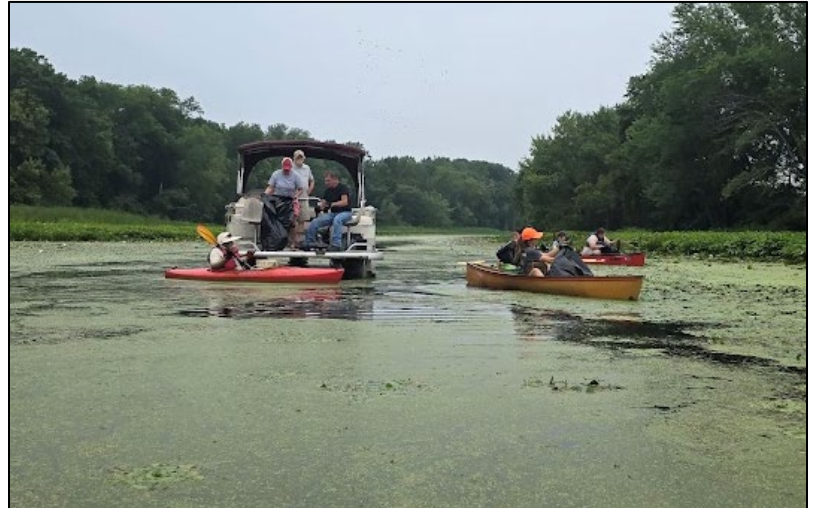
Figure 6. Full bag hand-off. Participants shown handing full bags to co-owner John Still & others on a pontoon boat for ease of hauling.

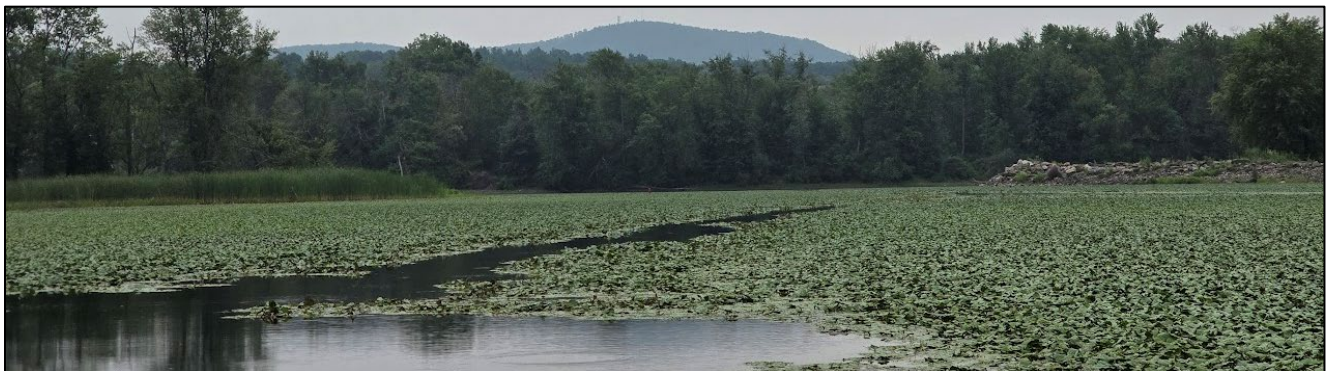
Figure 7. Southeast of treatment polygon. The narrow path disappears into the Water Chestnut monoculture, more than 820 feet from The Cove's confluence with the Hudson River.

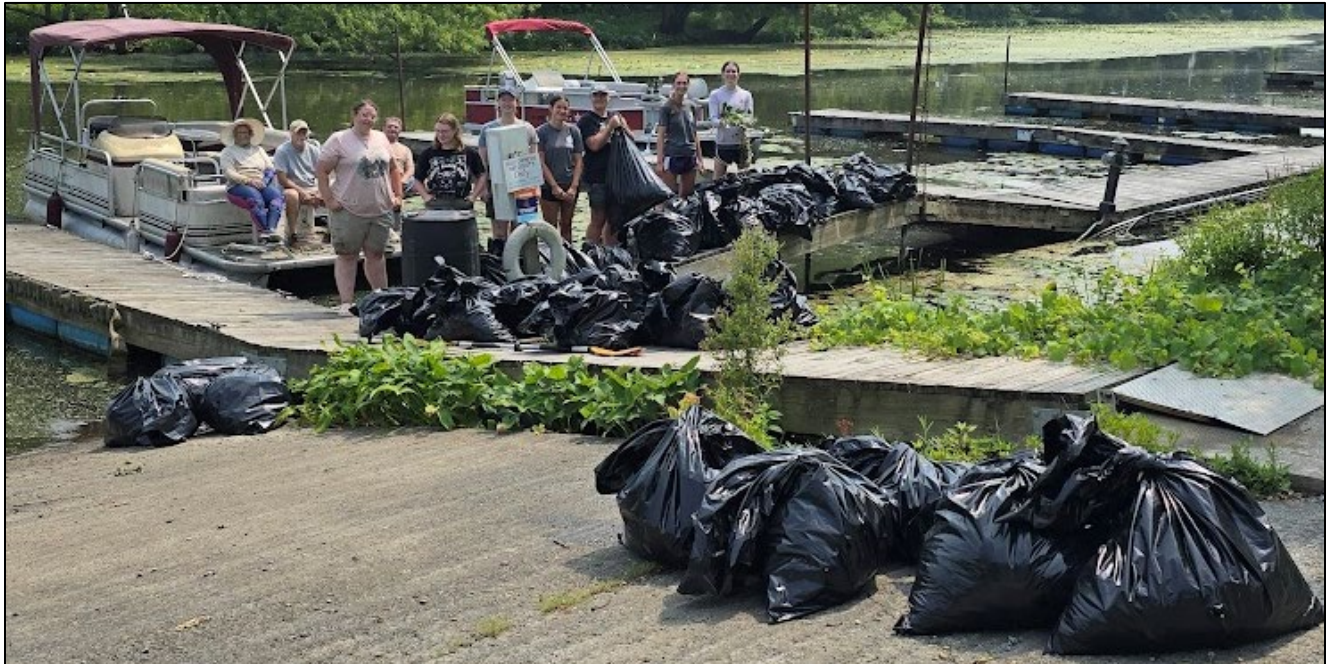
Figure 8. *Group photo.* Pictured are 10 of 11 participants, along with the 39 bags (approx. 1,300 lbs.) of removed biomass.
